**Aquatic Center Master Plan
Boulder City Project
No. 17-1013-MC(1)**

INTRODUCTION

FINAL REPORT

SUMMARY OF HISTORICAL DATA AND FIELD INVESTIGATIONS: ARCHITECTURAL

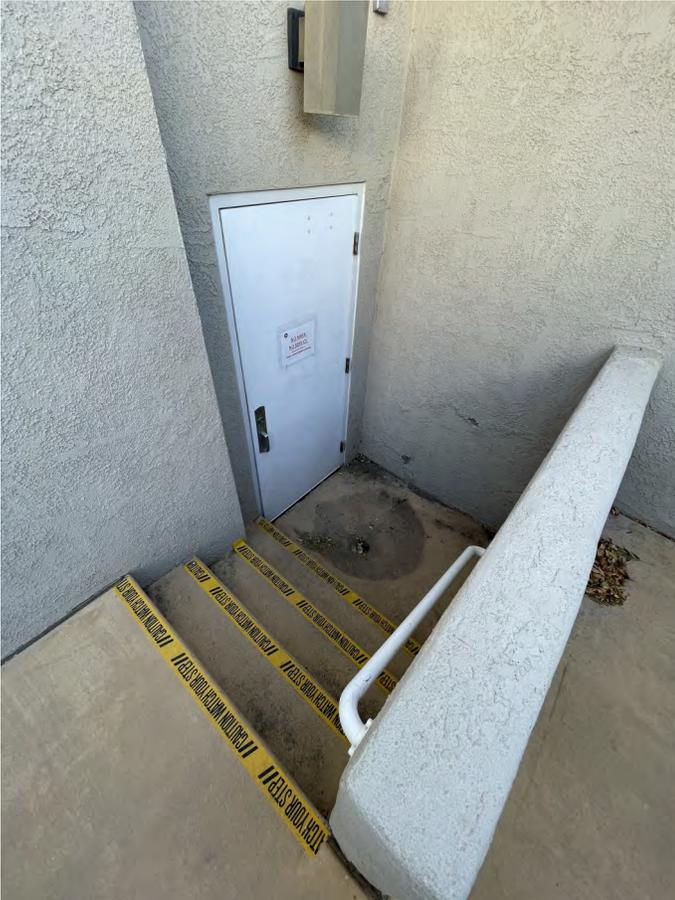
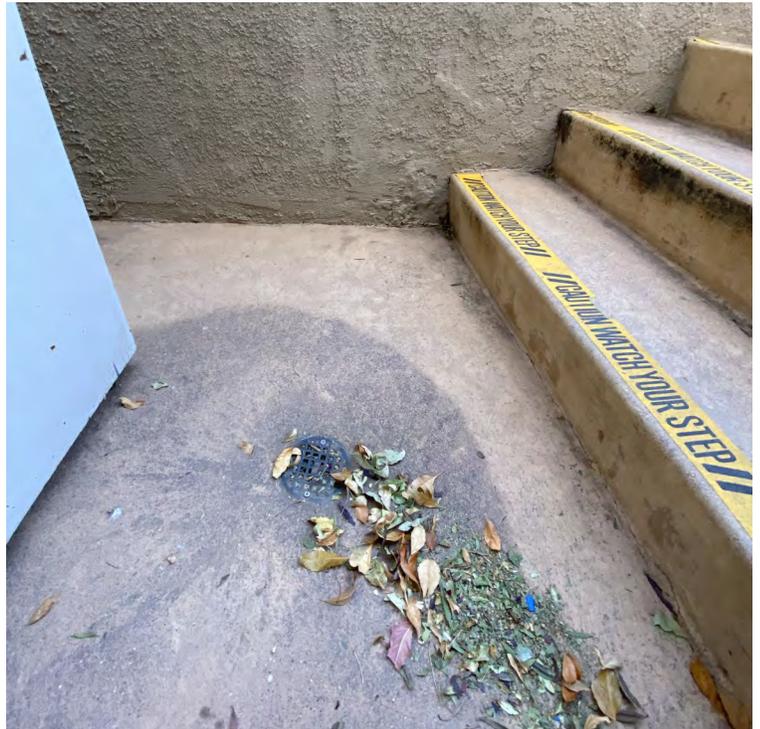
Area E: Existing Electrical– Pump Room/Storage

The bathhouse (mechanical/ pump/ chemical rooms) showed deterioration, chemical build up, in equipment, fixtures, pipes, and systems. Electrical/ mechanical/ pump room showed equipment dating from the 1980s in well need of repair/ replacement. Staff reported having to go swimming in the pit when repairs were needed as the accessibility for repairs was not possible at the ground level. Safety equipment was inaccessible and aged. Chemicals were stored improperly, causing possible safety hazards.

Remove existing pump equipment and pit; new CMU wall; new in-fill with concrete slab where pit was removed (approx. 8 feet in depth); new door

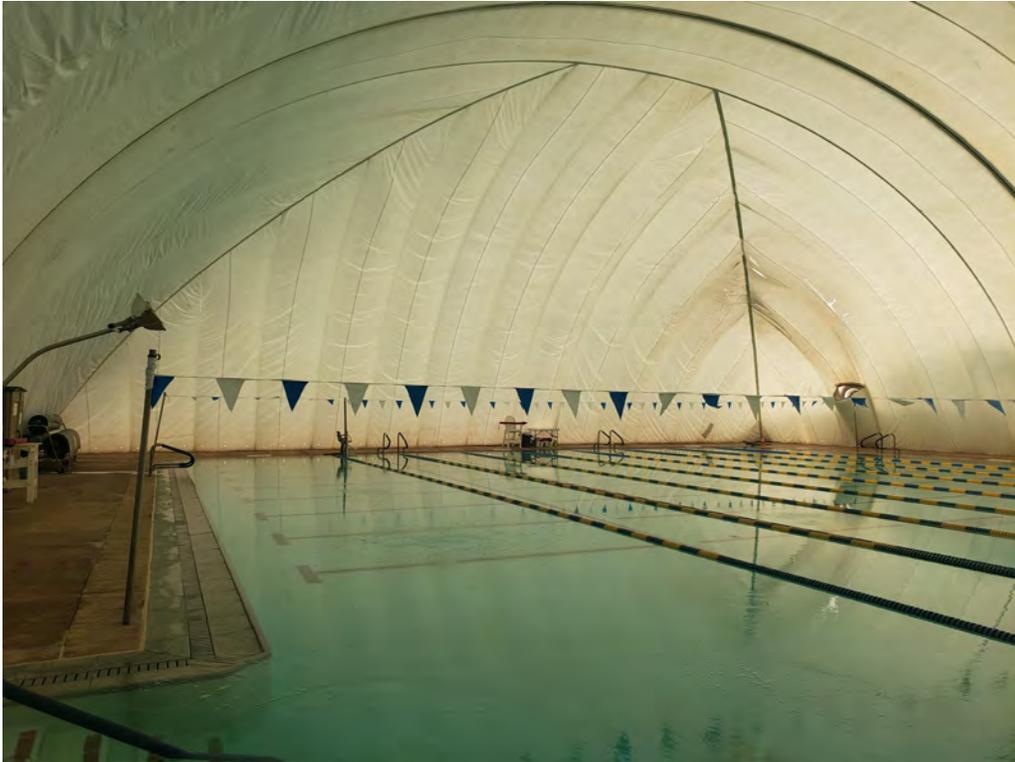
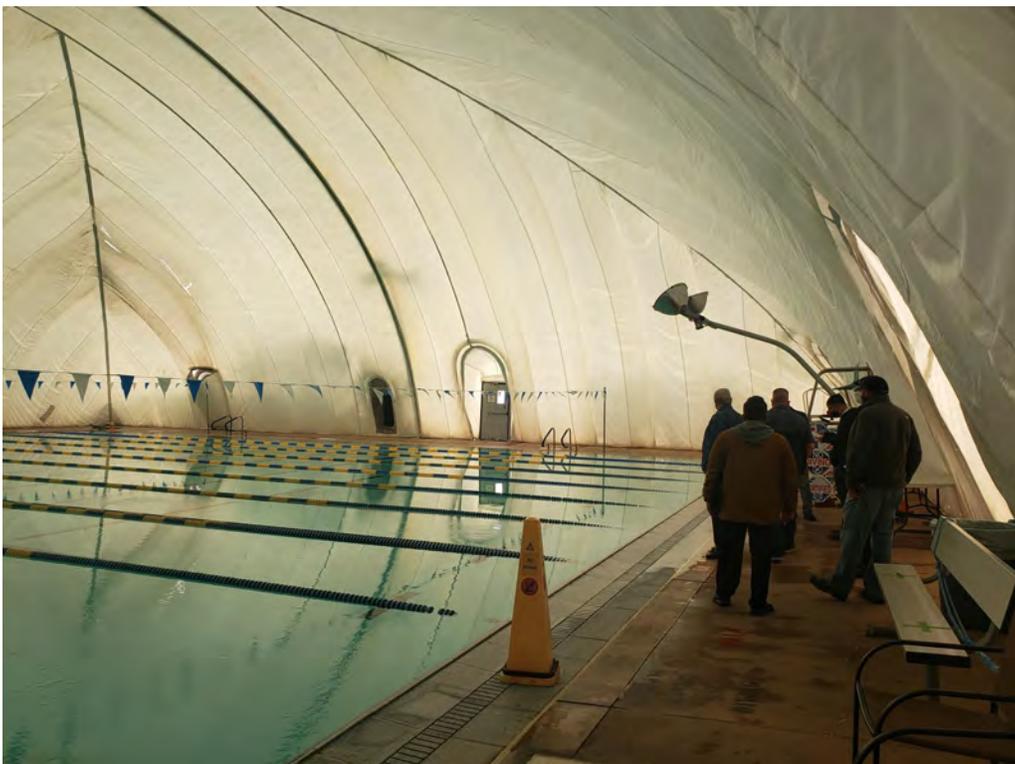
Area G: Swimming Pools

A temporary bubble has been constructed around the main pool. The temporary structure is more permanent than temporary as it is only removed during peak summer months and otherwise installed year-round. Bubble and exists are not ADA compliant. Exits are trip hazards causing safety concerns.

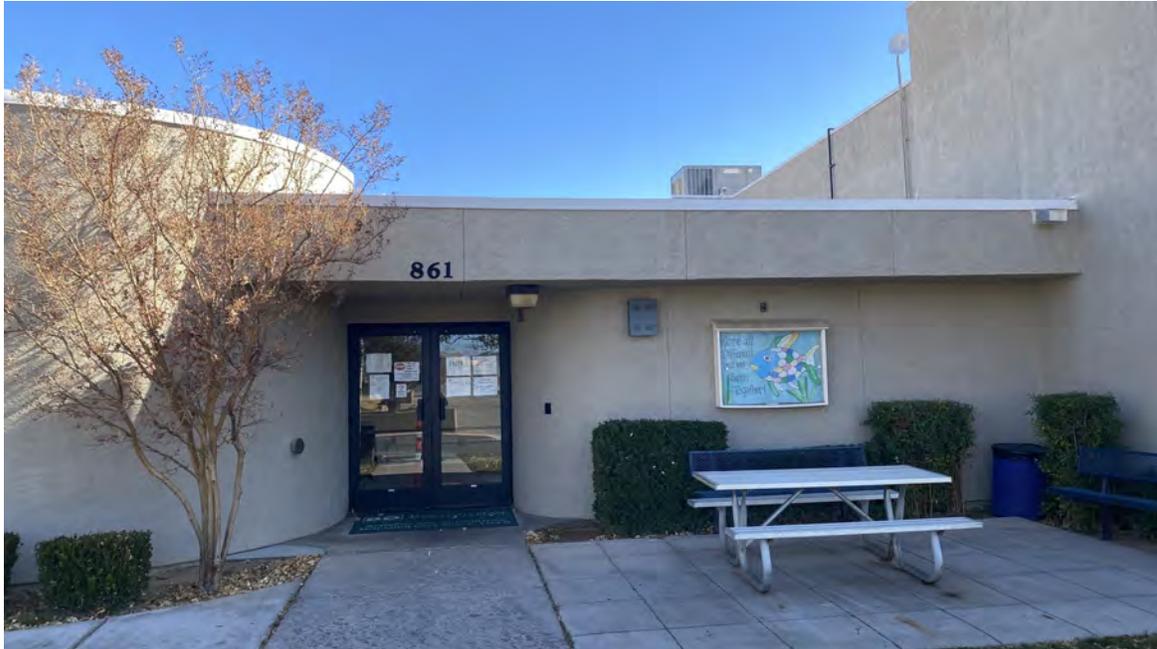
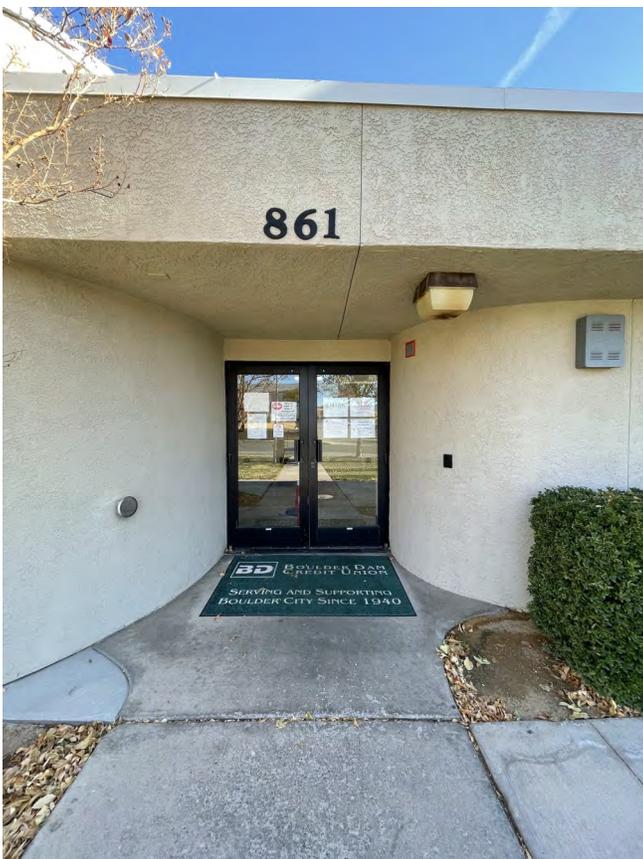
Area J: Site ADA Accessibility

The facility showed areas inaccessible to guests/staff with ADA accessible requirements. Temporary laundry/ waste baskets, benches and other obstructions caused areas of the facility, including the ADA lift to be inaccessible, as well as problems for ingress/egress and possible hazards in an emergency. Restrooms in this area are not ADA accessible. A baby changing station was absent in the facility.

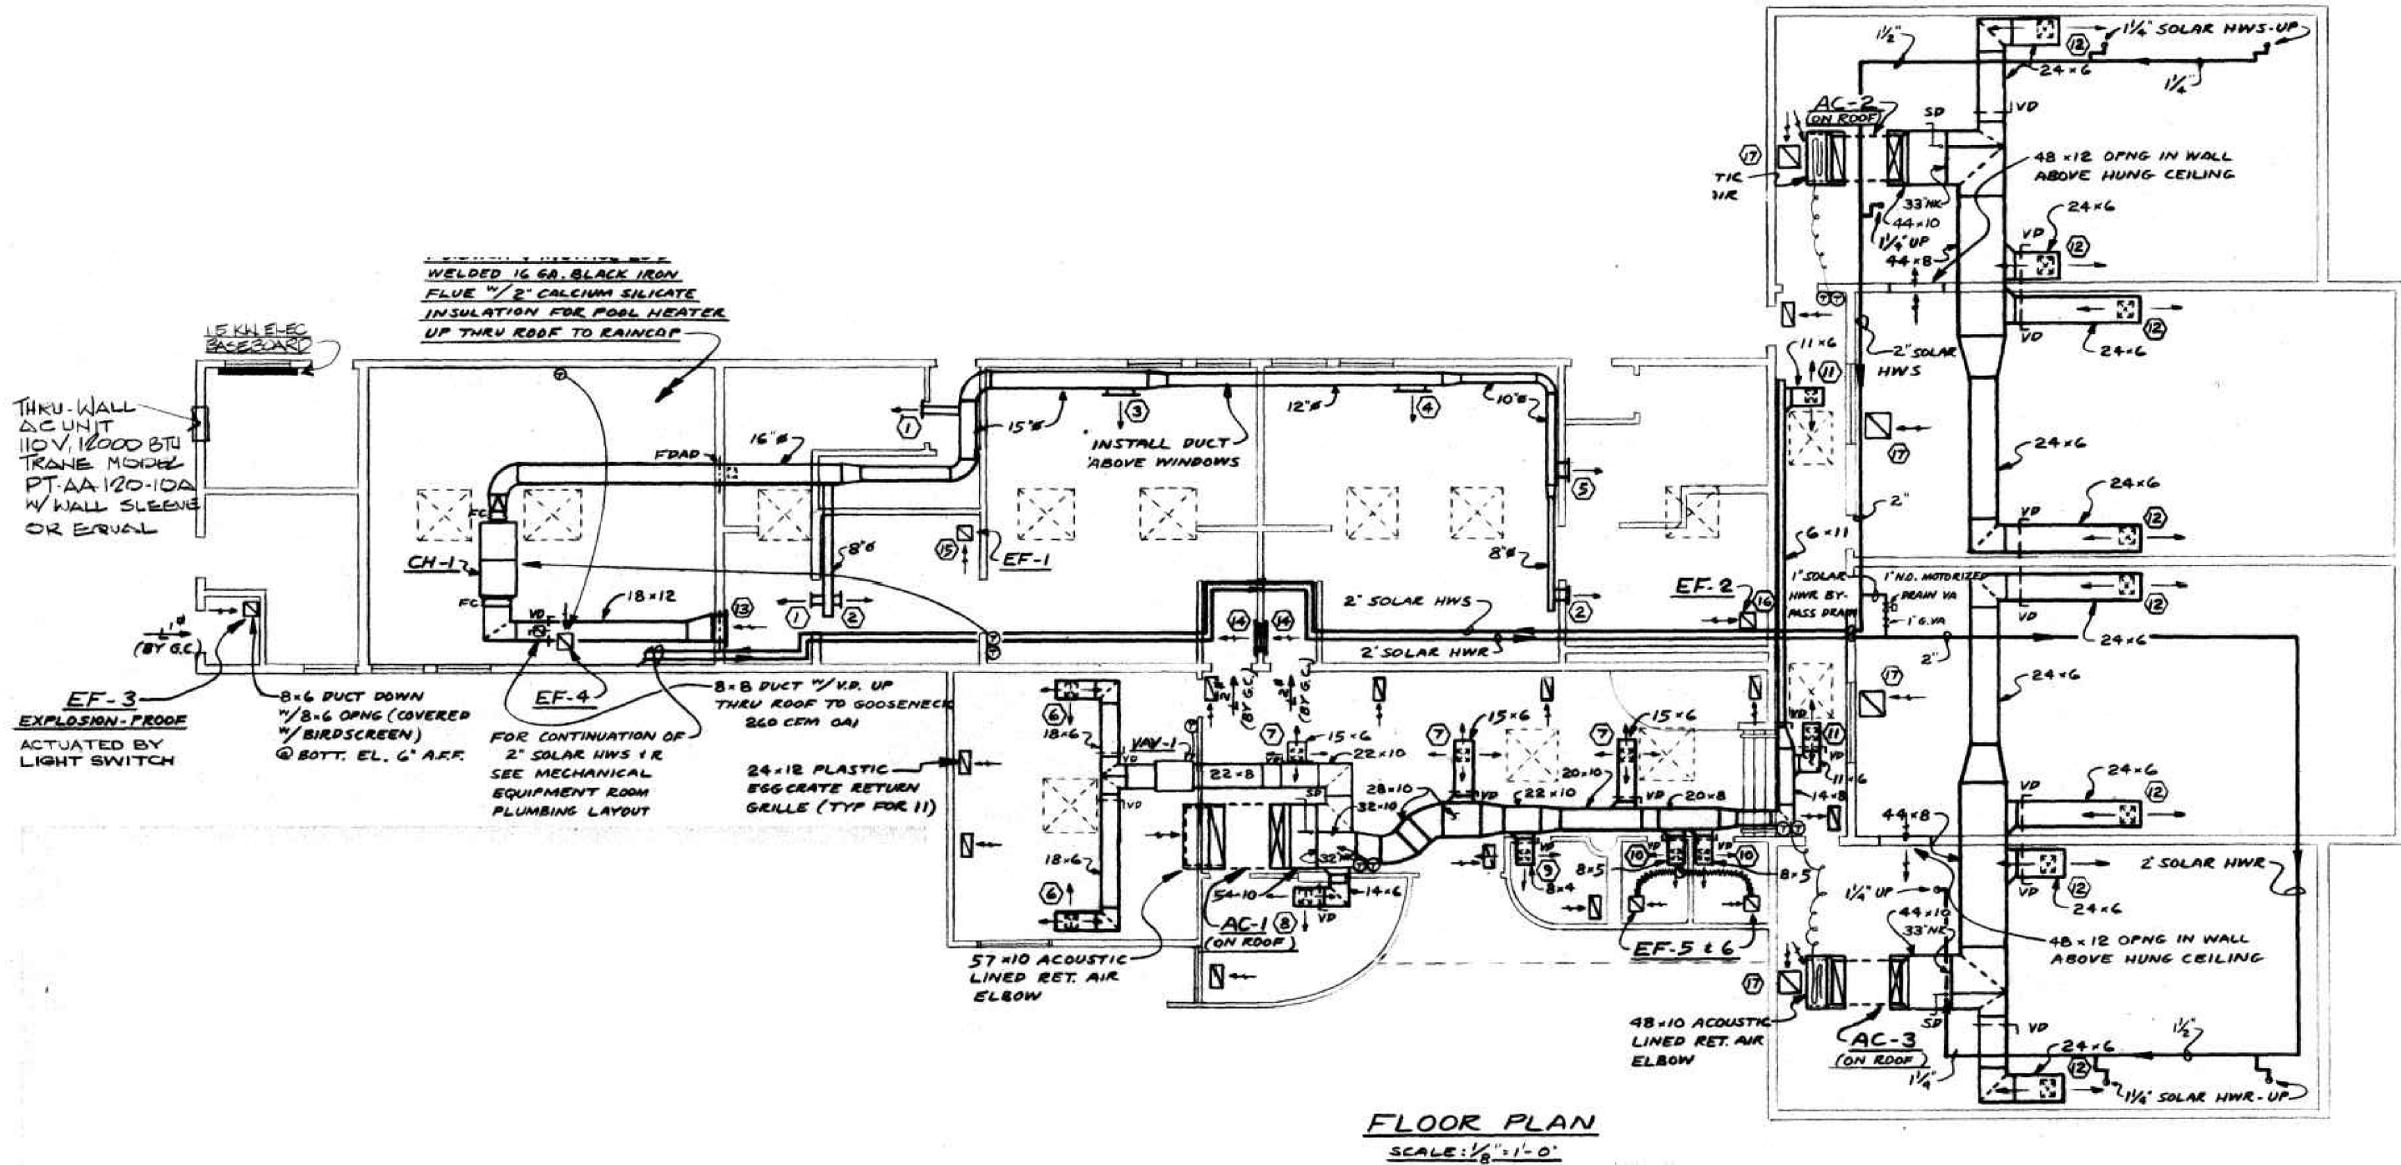
(A) MECHANICAL EXSTING (SHOWN FOR REFERENCE)
NO SCALE

This area is served by (1) rooftop Evaporative cooler and exhaust fan. The pool boiler and domestic water heater have the corresponding flues extending up thru the roof. The life guard office has a 1.5Ton ductless split. The electrical main gear room has no AC or ventilation. There are general receptacles and lighting throughout that need to be replaced in entirety. All electrical panels and main gear appear to have significant amount of corrosion due to the environment present. The chemicals used by the pool water system have created the corrosion that is present. The electrical gear is open to the pool chemicals used. The domestic water is copper and waste/vent piping is cast iron. The cast iron piping appears to be damaged due to corrosion.

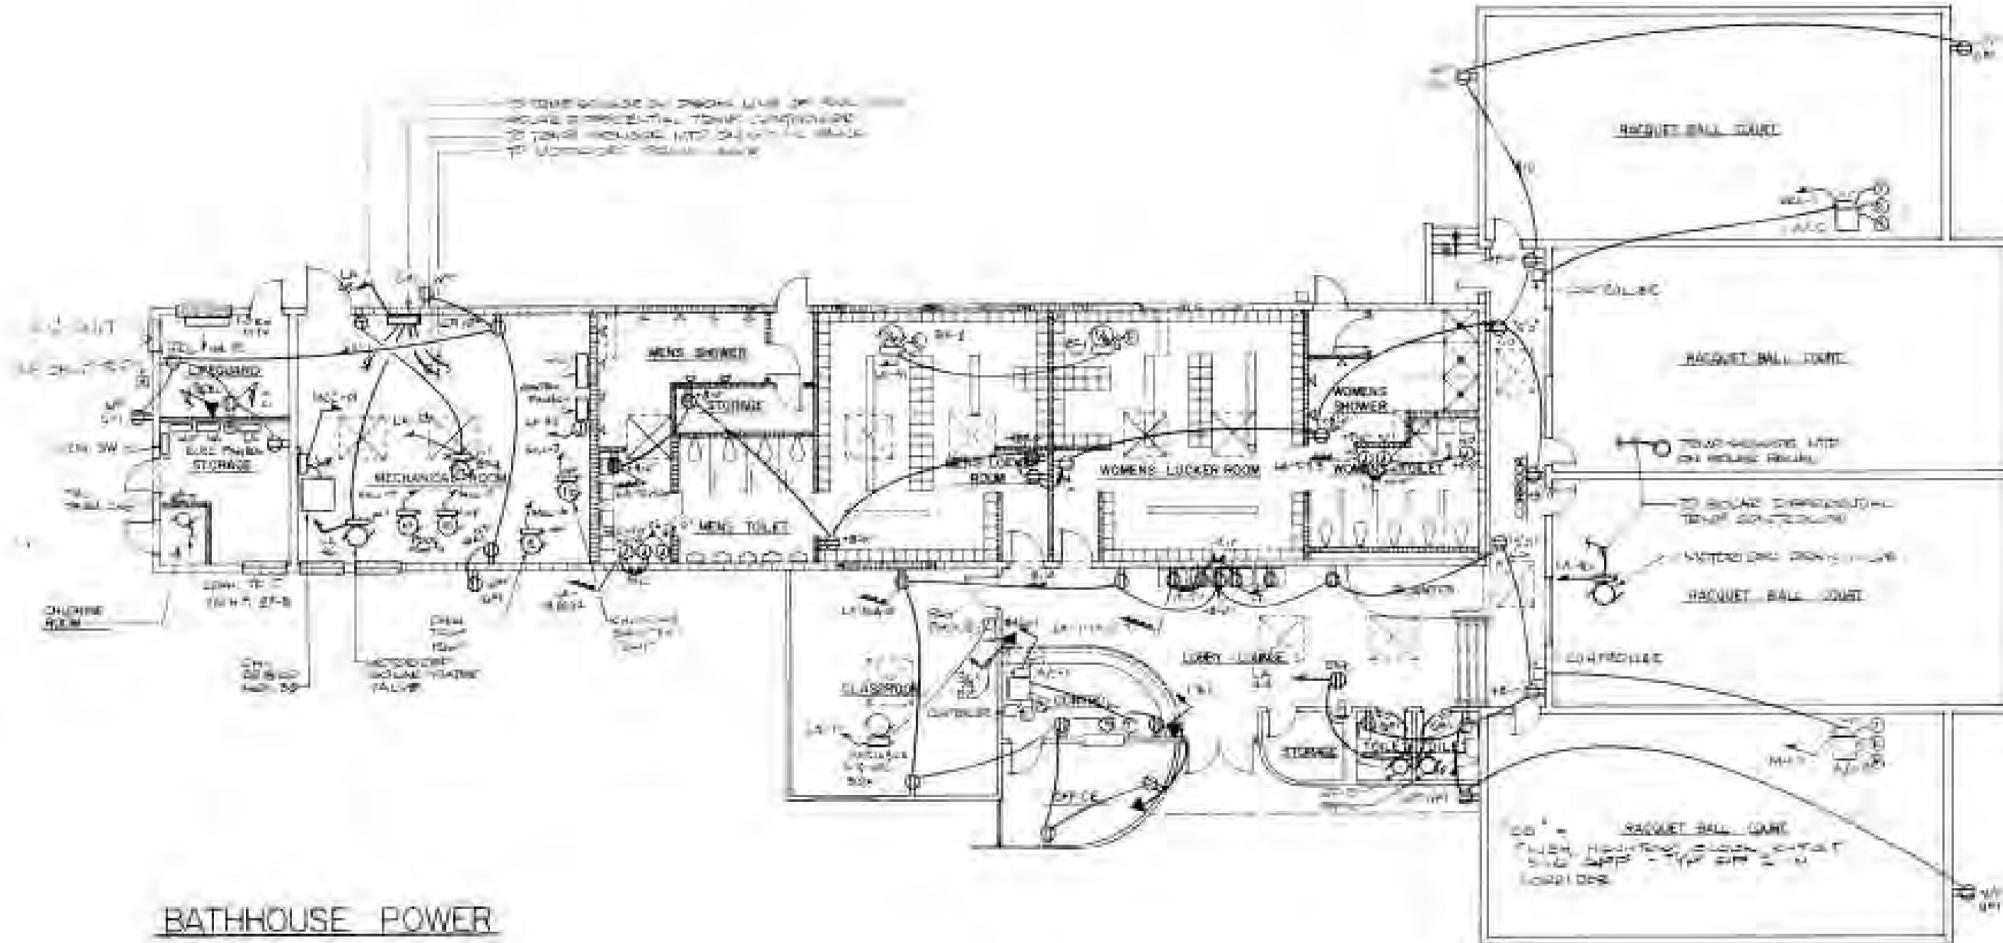
BATHHOUSE POWER

There are general receptacles and lighting throughout that appear to be in working condition but require electrician verification to confirm if corrosion exist. All electrical panels serving area are located in area E. The (2) single restrooms are provided with general plumbing. The domestic water is copper and waste/vent piping is cast iron.

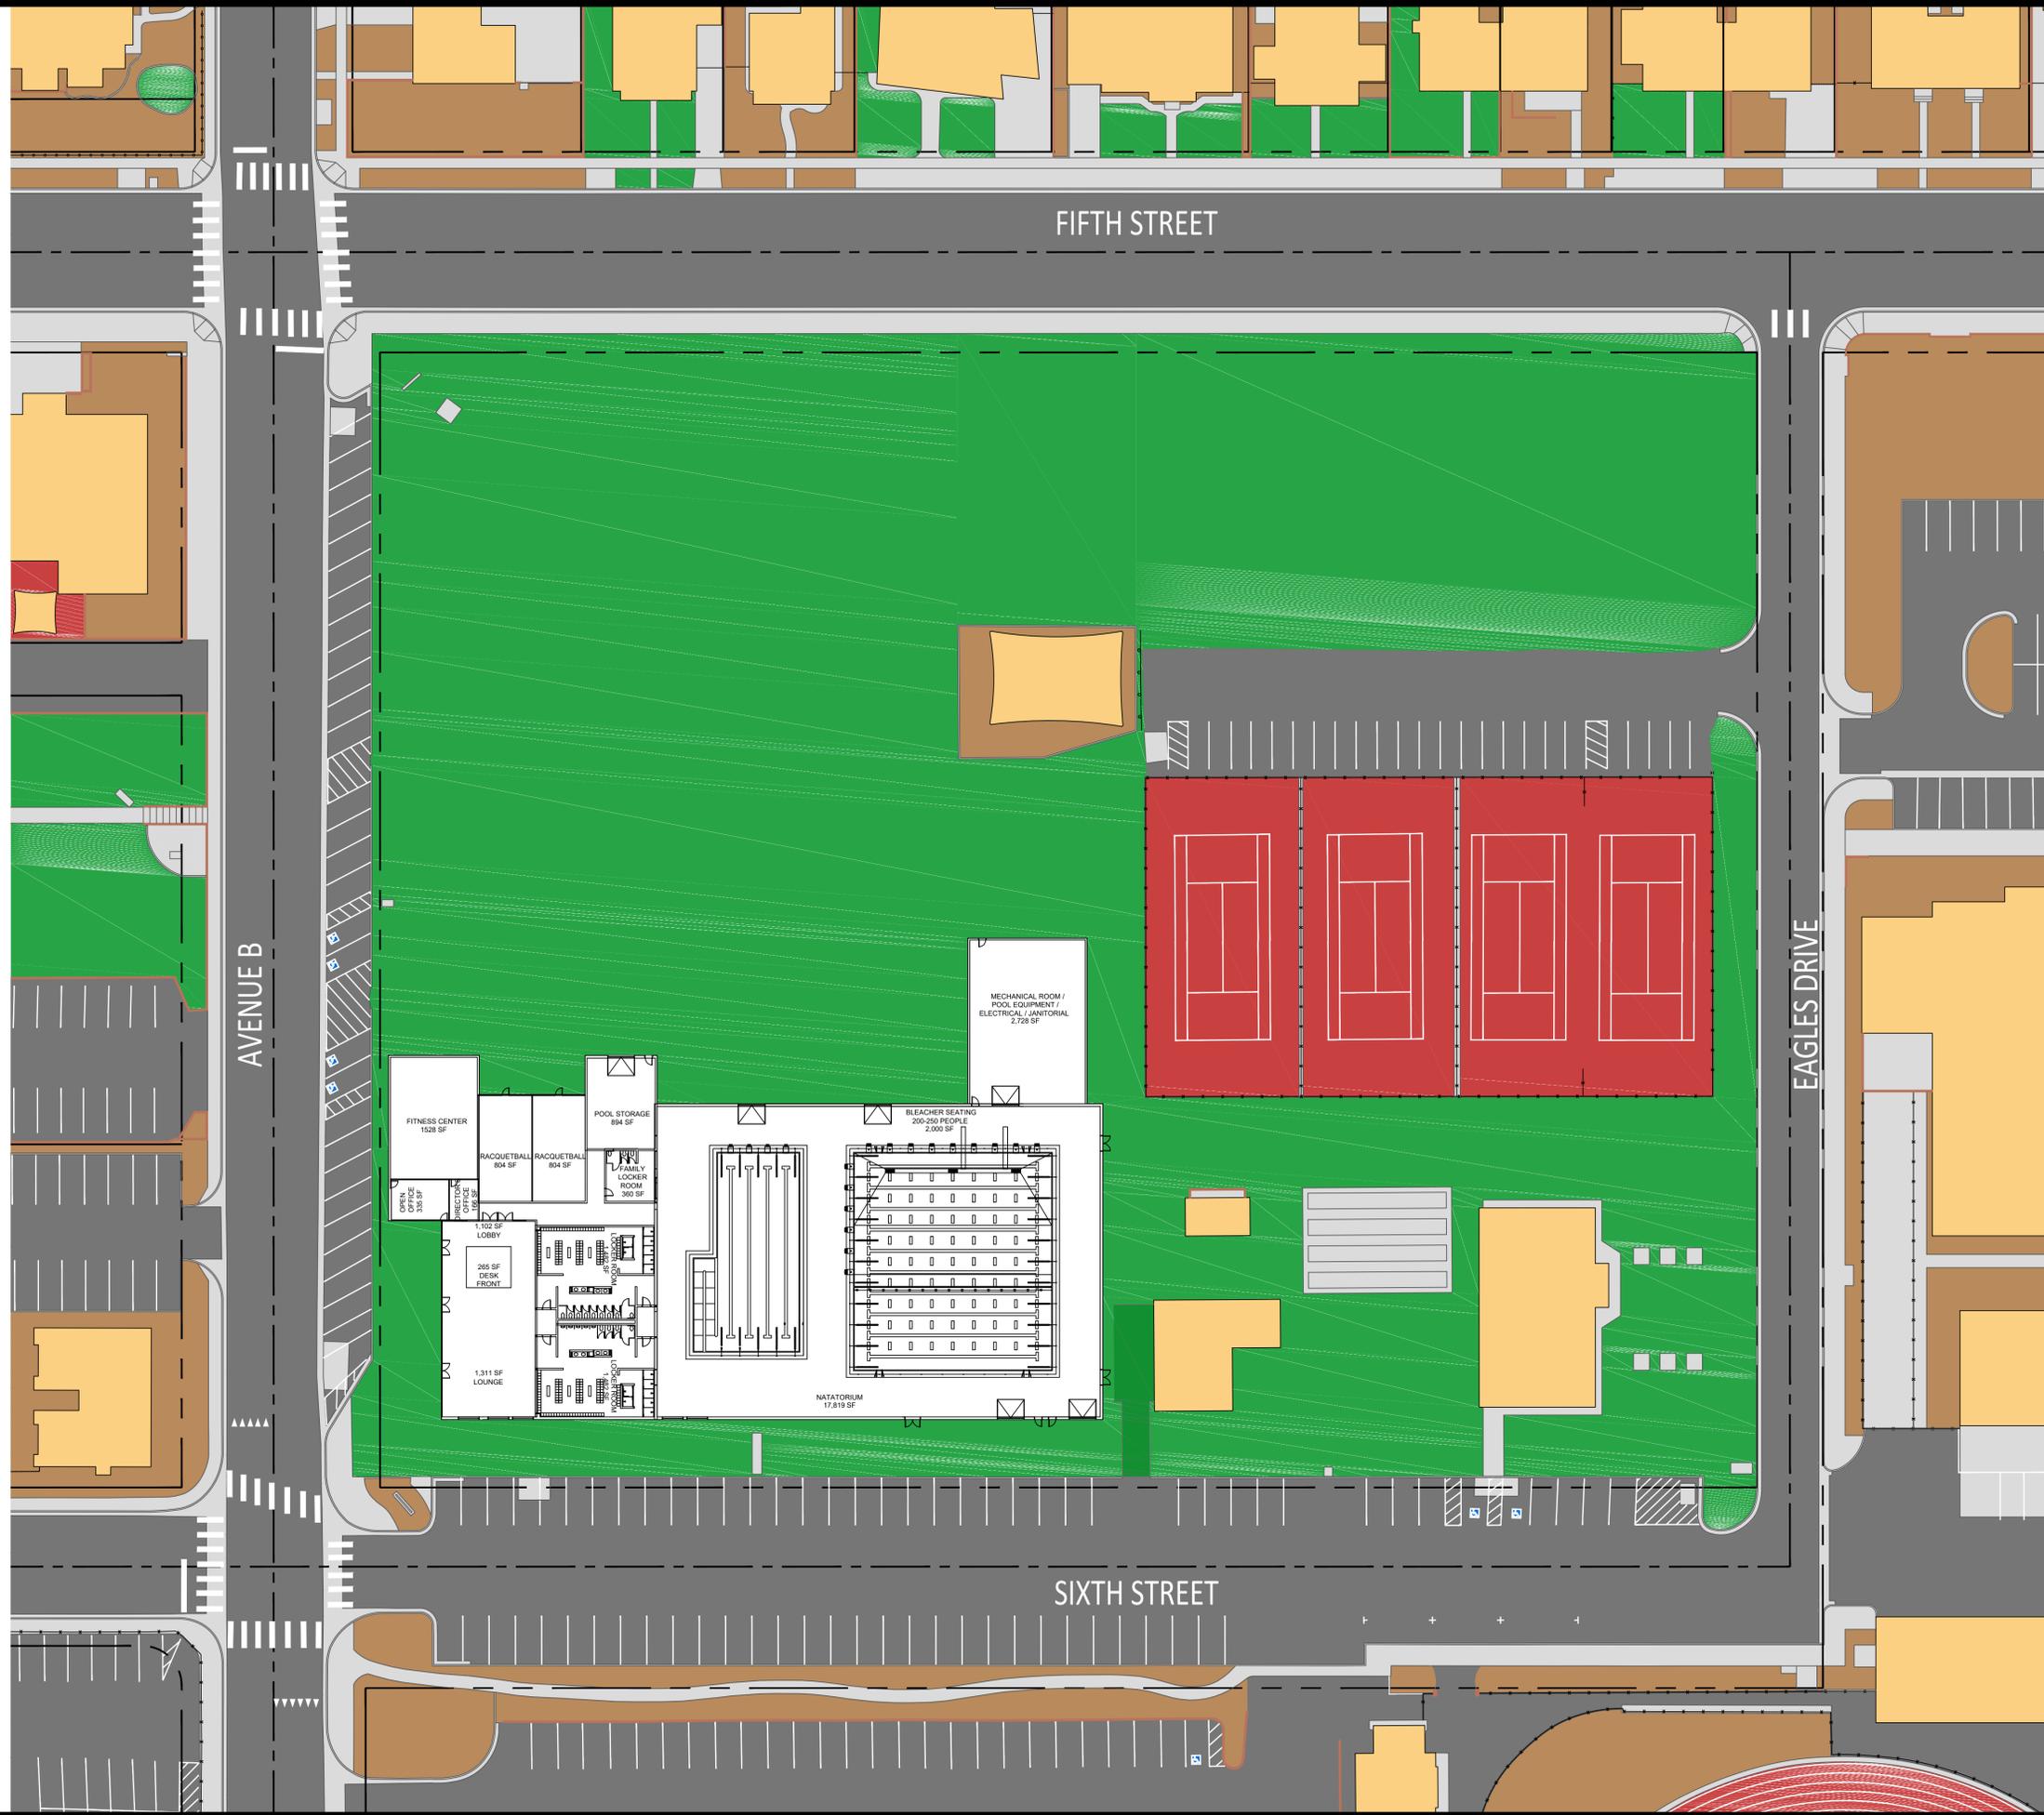
FITNESS CENTER 1528 SF
 OPEN 358 SF
 OFFICE 103 SF
 RACQUETBALL 804 SF
 RACQUETBALL 804 SF
 FAMILY LOCKER ROOM 360 SF
 POOL STORAGE 854 SF
 1,102 SF LOBBY
 285 SF DESK FRONT
 1,311 SF LOUNGE
 MECHANICAL ROOM / POOL EQUIPMENT / ELECTRICAL / JANITORIAL 2,728 SF
 BLEACHER SEATING 200-250 PEOPLE 2,900 SF
 NATATORIUM 17,819 SF
